MODEL XPB2Y-4 AIRPLANEREPORT NO. ZH-29-018XPB2Y-4HYDRODYNAMIC CHARACTERISTICSPart ISpray Strips InstalledFOREWORD

Reported herein is an analysis of flight tests conducted on the XPB2Y-4 airplane, equipped with Wright R-2600-10 Engines, to determine the hydrodynamic characteristics with spray strips installed. Three power settings were used; namely, 1800, 1700, and 1200 BHP/Engine. The latter power was used to simulate the characteristics of the normal PB2Y-3 airplane, and was not used in excess of 72,500 pounds gross weight which is the practical limiting load for that power. Due to a restriction of only four take-offs at 1800 BHP/Engine, the data at this power are necessarily limited.

MODEL XPB2Y-4 AIRPLANEREPORT NO. ZH-29-018DISCUSSIONA. Effect of Spray Strips on the Hydrodynamic Characteristics of the PB2Y-3 and XPB2Y-4 AirplanesBrief:

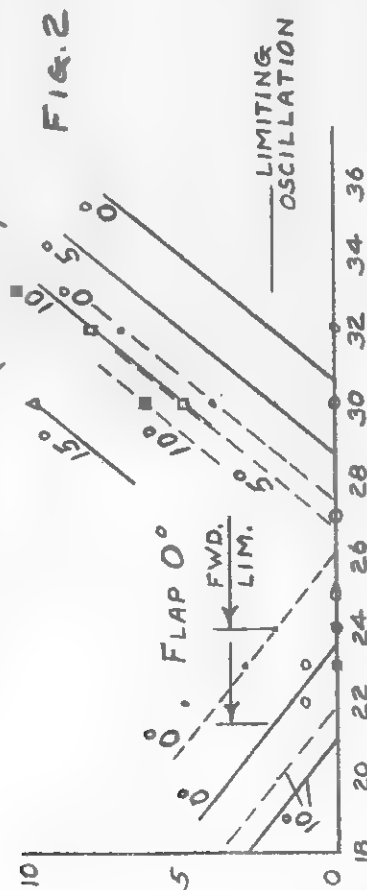
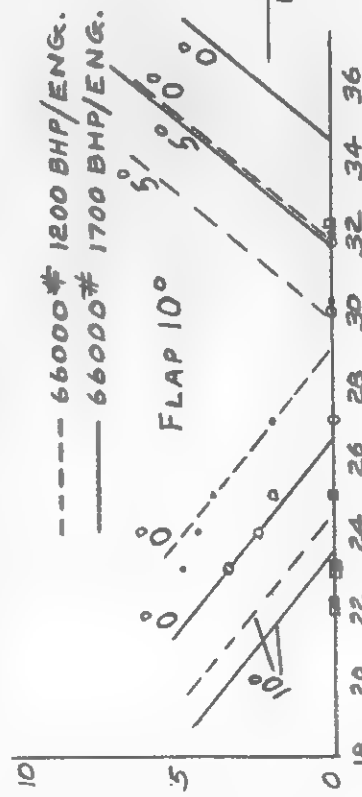
FIG. 2

Figure 2 is the basic plot and contains all of the actual test points. It is plotted in the form described in Reference 2 where the maximum amplitude of oscillation attained during an accelerated run to near getaway with the elevator fixed is plotted against center of gravity position in % of the mean aerodynamic chord. This method is known as determining the center of gravity limits and has proved through extensive full scale and model testing to be the most practical procedure for defining hydrodynamic stability.

The forward c.g. limit of stability has been defined as that c.g. position where a maximum oscillation of ± 1.0 degree is obtained with the elevators locked at 0 degrees. This definition allows enough conservatism to provide for inaccurate loading in service and rough water. It will be noted that the application of 10 degrees of up elevator is sufficient in most cases to move the limit forward an additional 3 or 4% M.A.C.

HYDRODYNAMIC LIMITS OF STABILITY FOR TAKEOFF
(1700 BHP/ENG - WITH SPRAY STRIPS)

Figures 2 through 8 present the effects of varying power loading and beam loading on the hydrodynamic stability characteristics. As in the case of the observations on spray, acceleration has a marked effect.

The aft c.g. limit of stability has been defined as that c.g. position where a maximum oscillation of ± 1.0 degree is obtained with the elevators locked up at 5 degrees. This limit has been modified from one previously established by this company for model tests wherein an angle of 25 degrees of up elevator was specified. This modification has been the result of an extensive full-scale survey of the take-off technique of a number of pilots, which indicated that seldom is more than 5 degrees of up elevator used during the take-off run, particularly if the c.g. is in the aft of normal range. The 25-degree elevator, in light of this survey, is deemed unnecessarily conservative.

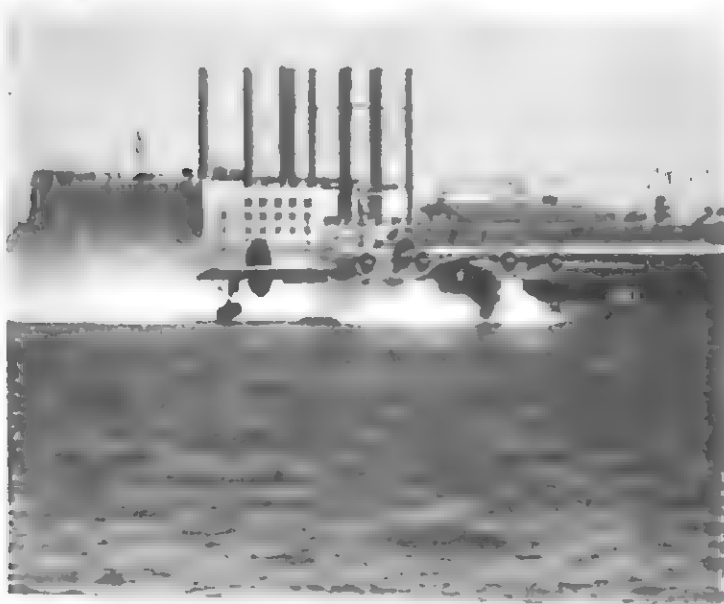
76000 LBS

1800 BHP/ENG.

For direct comparison, a moving picture record at each power was obtained at a c.g. of 27% M.A.C. for the 66,000, 72,500, 74,000 and 76,000 pound conditions. Summary spray pictures enlarged from these records are shown in Figures 10 through 12. Tabulated data obtained from these records and direct observations are given in Table I.

increased power and at 76,000 pounds with 1700 and 1800 BHP/Engine the spray was considerably reduced over the worst condition at 72,500 pounds.
